RRIS Technical Support Bulletin # 1048

SUBJECT: Console may experience lockup when CUE audio is played

PRODUCT: RMX*digital* KSU circuit boards, PN 95-2672-(1/2)

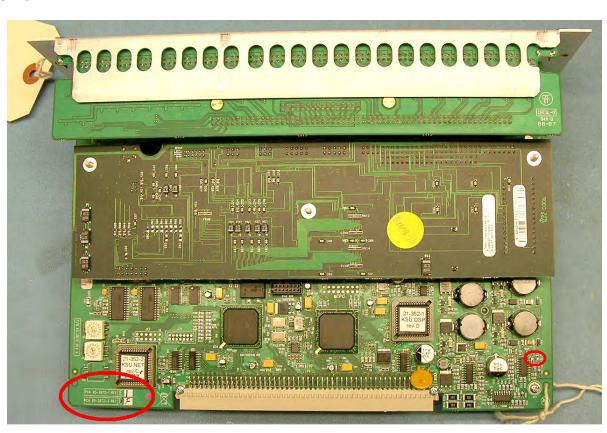
REQUIRED ACTION: Visually inspect the console to determine whether or not capacitor C63 is present on the KSU module. The following image shows the locations of the revision markings (to the left) and capacitor C63 (to the right) on the KSU module:

If a KSU module is found on which C63 is present, the capacitor must be removed from the board. This may be accomplished by using two conventional soldering irons in a tweezers-like fashion to simultaneously melt the solder on both sides of the component, and then lift it up off of the circuit board. No other modifications are necessary. In order to service the KSU module, the power to the console must be shut off, and the KSU module removed from the top of the console by unscrewing and then pulling up on the two or four knurled thumbsrews which secure the module to the console.

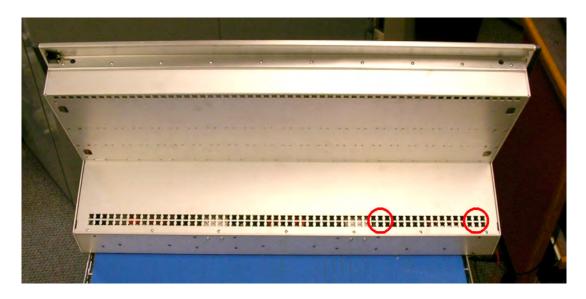
The KSU module is installed in the right-most slot under the console's hinged top cover. The revision markings and the location of capacitor C63 can be viewed through the ventilation holes in the console's lower-front cover, which is below countertop level. The following picture shows the areas through which the revision markings (leftmost circle) and C63 (rightmost circle) can be viewed. A small flashlight is usually required to see clearly in this area:

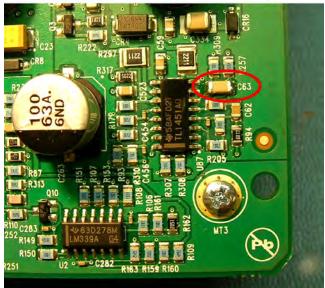
C63 installed (INCORRECT)

Below are close-up images of the location of capacitor C63 on the KSU circuit board. The capacitor does not bear any markings on its case, and may be offwhite, tan, or orange-brown in color:

Proper ESD precautions much be observed when handling the KSU while it is removed from the console, and the use of grounded-tip irons is recommended when removing C63. Harris Tech Support in Vista, CA can also perform this modification if required.
